September 24, 1973

REPORT ON SKYLAB-M551 SAMPLES  
CONTRACT NO. NAS-8-28725

SPECIMEN PROCESSING

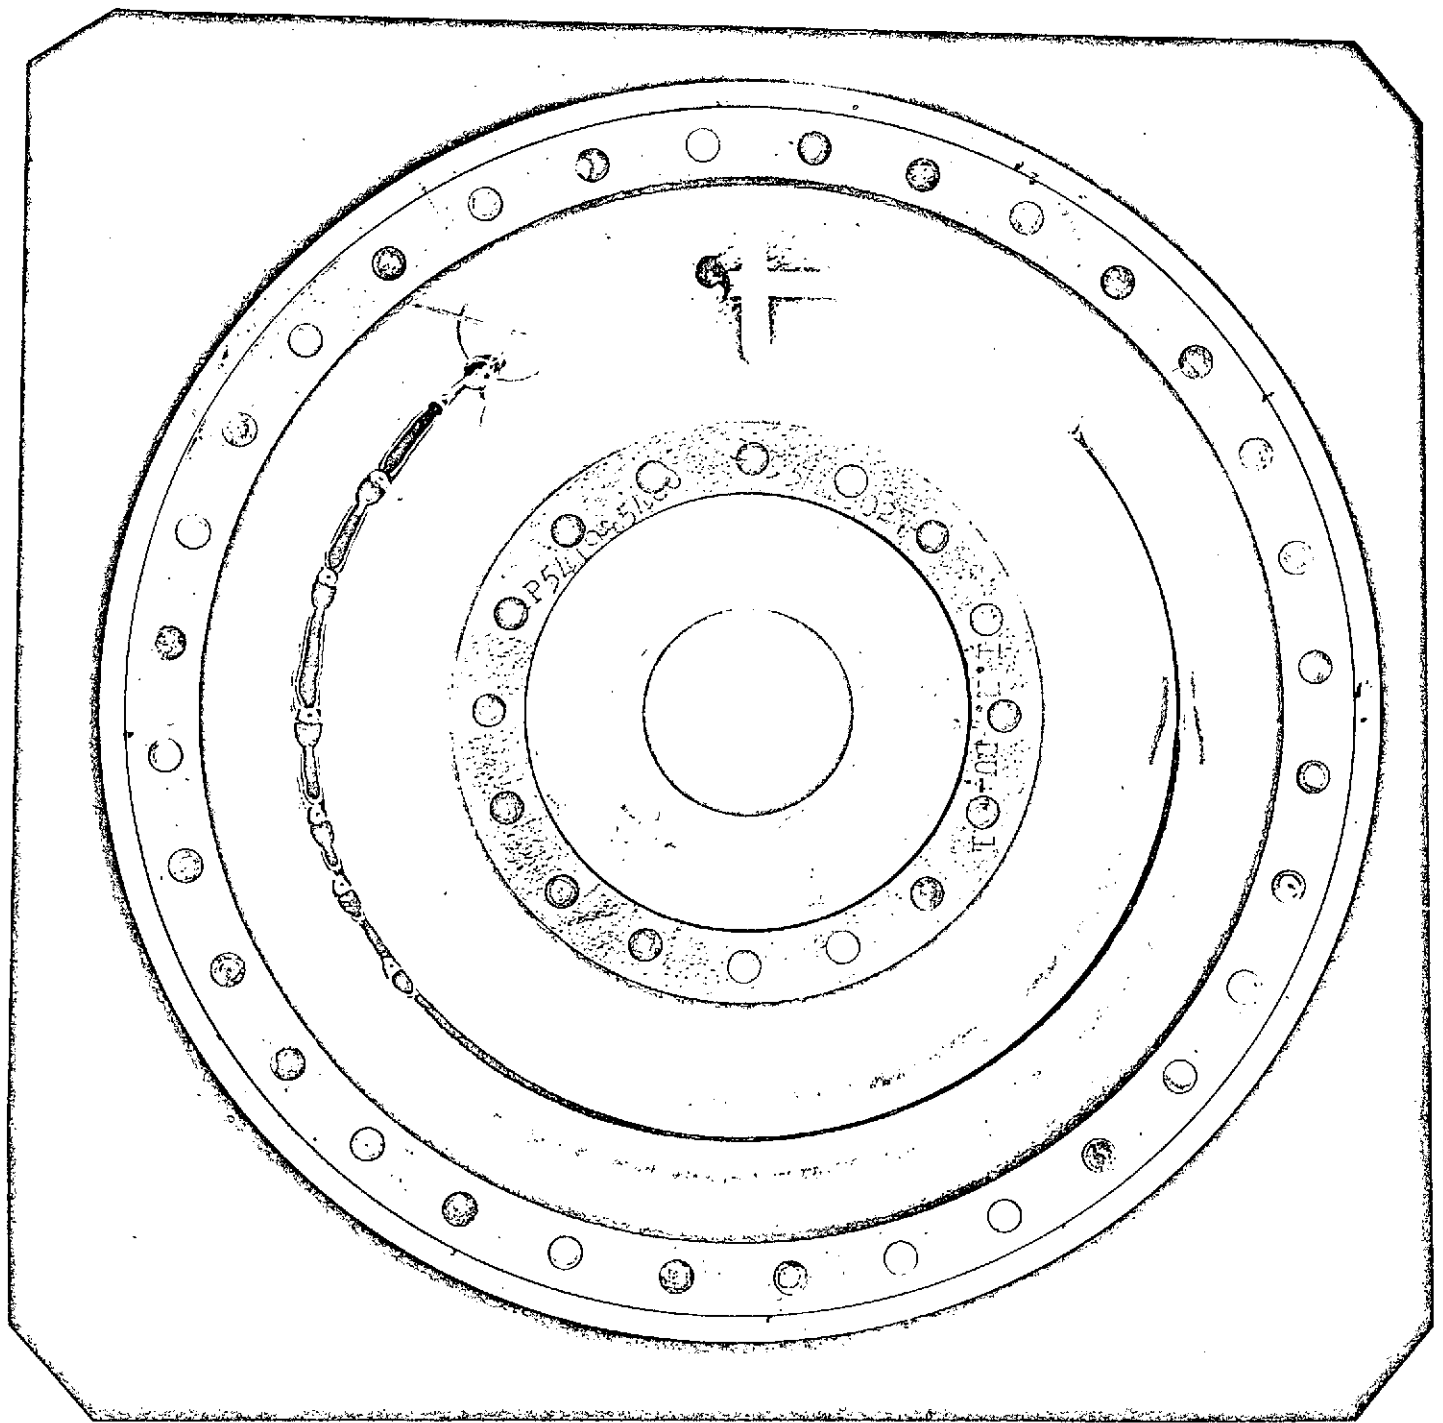
FIGURE IV-11. FRONT SURFACE S/N 145

Front Surface S/N 145

The target is integral on this sample. The beam was initiated within the target area but a little beyond the zero point and slightly to the inside. The surfaces of the tantalum welds are beautiful, showing both a ripple pattern where the beam was started and clear evidence of the grain structure on all of the surfaces. There is no evidence of any discoloration or oxidation. The cut region appears to start immediately at the thin section and is bridged periodically by a ball of molten tantalum. These balls show a ripple pattern on the side and clear grain structures elsewhere. There appears to be a cavity in the first ball evident on the top lower surface in the direction of increasing degrees. After each bridge, the gap tends to widen then narrow to a kerf which then tends to taper somewhat in width and also in the amount of molten metal that is piled up on each edge. This situation continues until the next bridge.

There are a total of 5 ball bridge regions. Each is quite similar in appearance to the first one described. Each bridge also appears to contain the cavity region described for the first ball. The bridges get progressively closer to one another along the length of the specimen. After the last bridge, there is a region that extends for about 9 millimeters with a hole at the end of this region. At this point, the weld itself starts. This weld is extremely uniform; one can see both the ripples and the surface grain structure

quite readily. This weld continues on through to the termination point. At approximately 185 degrees, there is a single surface depression on the inside edge of the weld. In the region where the molybdenum tracer is placed on the disc, there is the appearance of under cut having started on both the inside and outside edges of the weld. Also within the tracer region, there is a change in the width of the weld bead with it becoming narrower at the point where the thickness of the disc increases. The slight undercut condition appears to continue on to the termination of the weld at the termination hole. There were no cracks or other defects aside from the single surface depression noted in examination of this weld.

Additional examination of the area where the slight depression was noted on the inside surface of the weld suggest that there may have been a defect in the plate material at that point. This would appear to be a slight machining gouge.

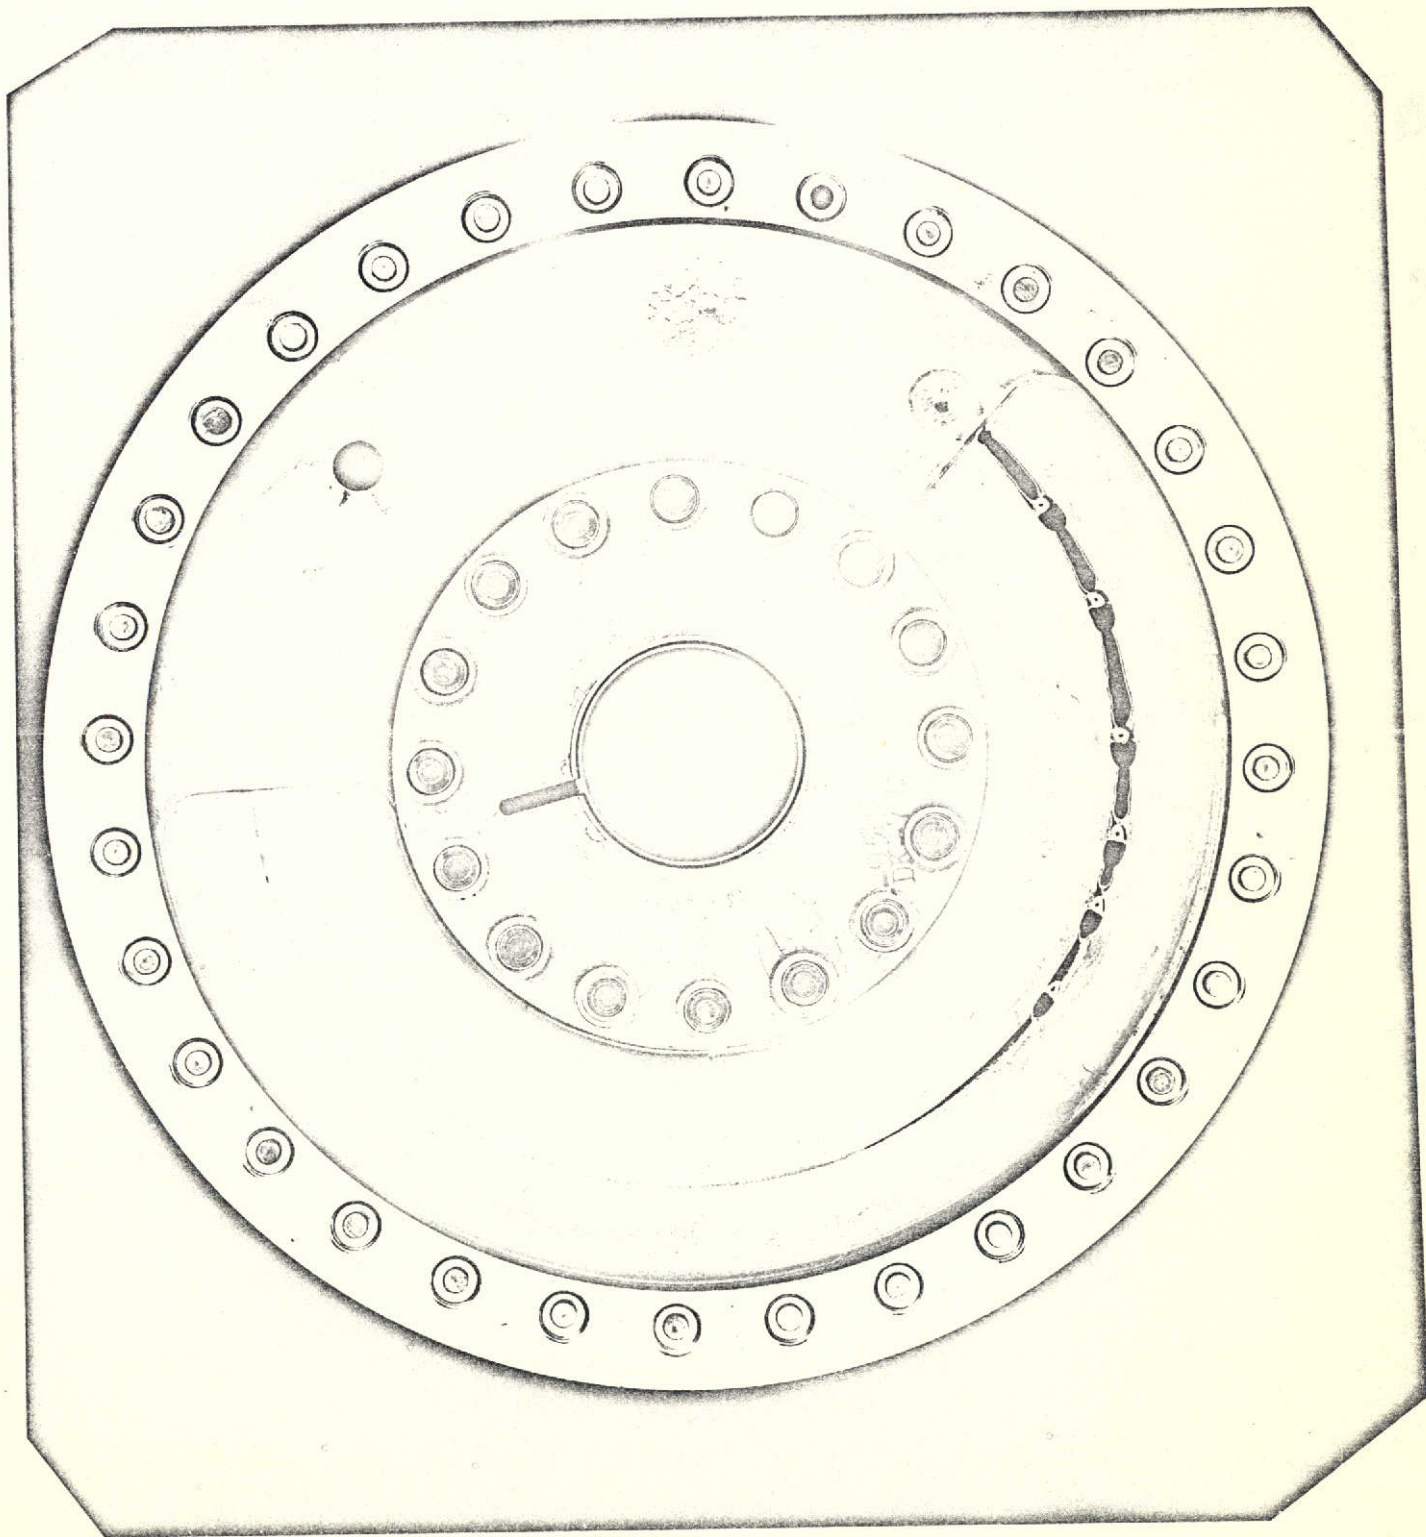
FIGURE IV-12. BACK SURFACE  
S/N 145

Back Side of S/N 145

Starting in the weld target area on the reverse side of the target, there is evidence of complete penetration. In fact, there appear to be two separate spot areas which were melted through to the back side and subsequently solidified. Surrounding the target area and still attached to the disc are a number of small spherical particles which are probably tantalum spatter that was ejected from the back side of the target area, bounced off the support plate, and then adhered to the tantalum. At least

8 of these small spheres can be seen in the field of view of the magnifying system. Moving away from the target once the beam-travel combination was initiated, penetration stopped until the thin section was reached at which point cutting action was initiated. The back side of the cut region does not appear to be significantly different from the front side with all of the same basic features being evident. The balls that constitute the bridges are raised above the bottom surface just as they were raised above the top surface on the front of the disc. Material present adjacent to the balls in the direction of increasing angle appears to have been pulled back into the bridge area. Appearance on the underside of the full penetration welds is quite similar to the appearance on the upper surface. The full penetration weld begins to taper after its initiation and there is no more penetration after about 135 degrees. Evidence of the presence of the weld continues as in the case of the stainless steel without full penetration being apparent. There is one short linear indication of full penetration at about 225 degrees. Some further evidence of welding is apparent on the reverse side even in the partial penetration region leading up to the termination hole. At the termination hole itself, there is evidence of penetration through the plate on the side where the weld was terminated. At the dwell region, there is no evidence of complete penetration although again, the grain structure and a surface roughening are quite evident.

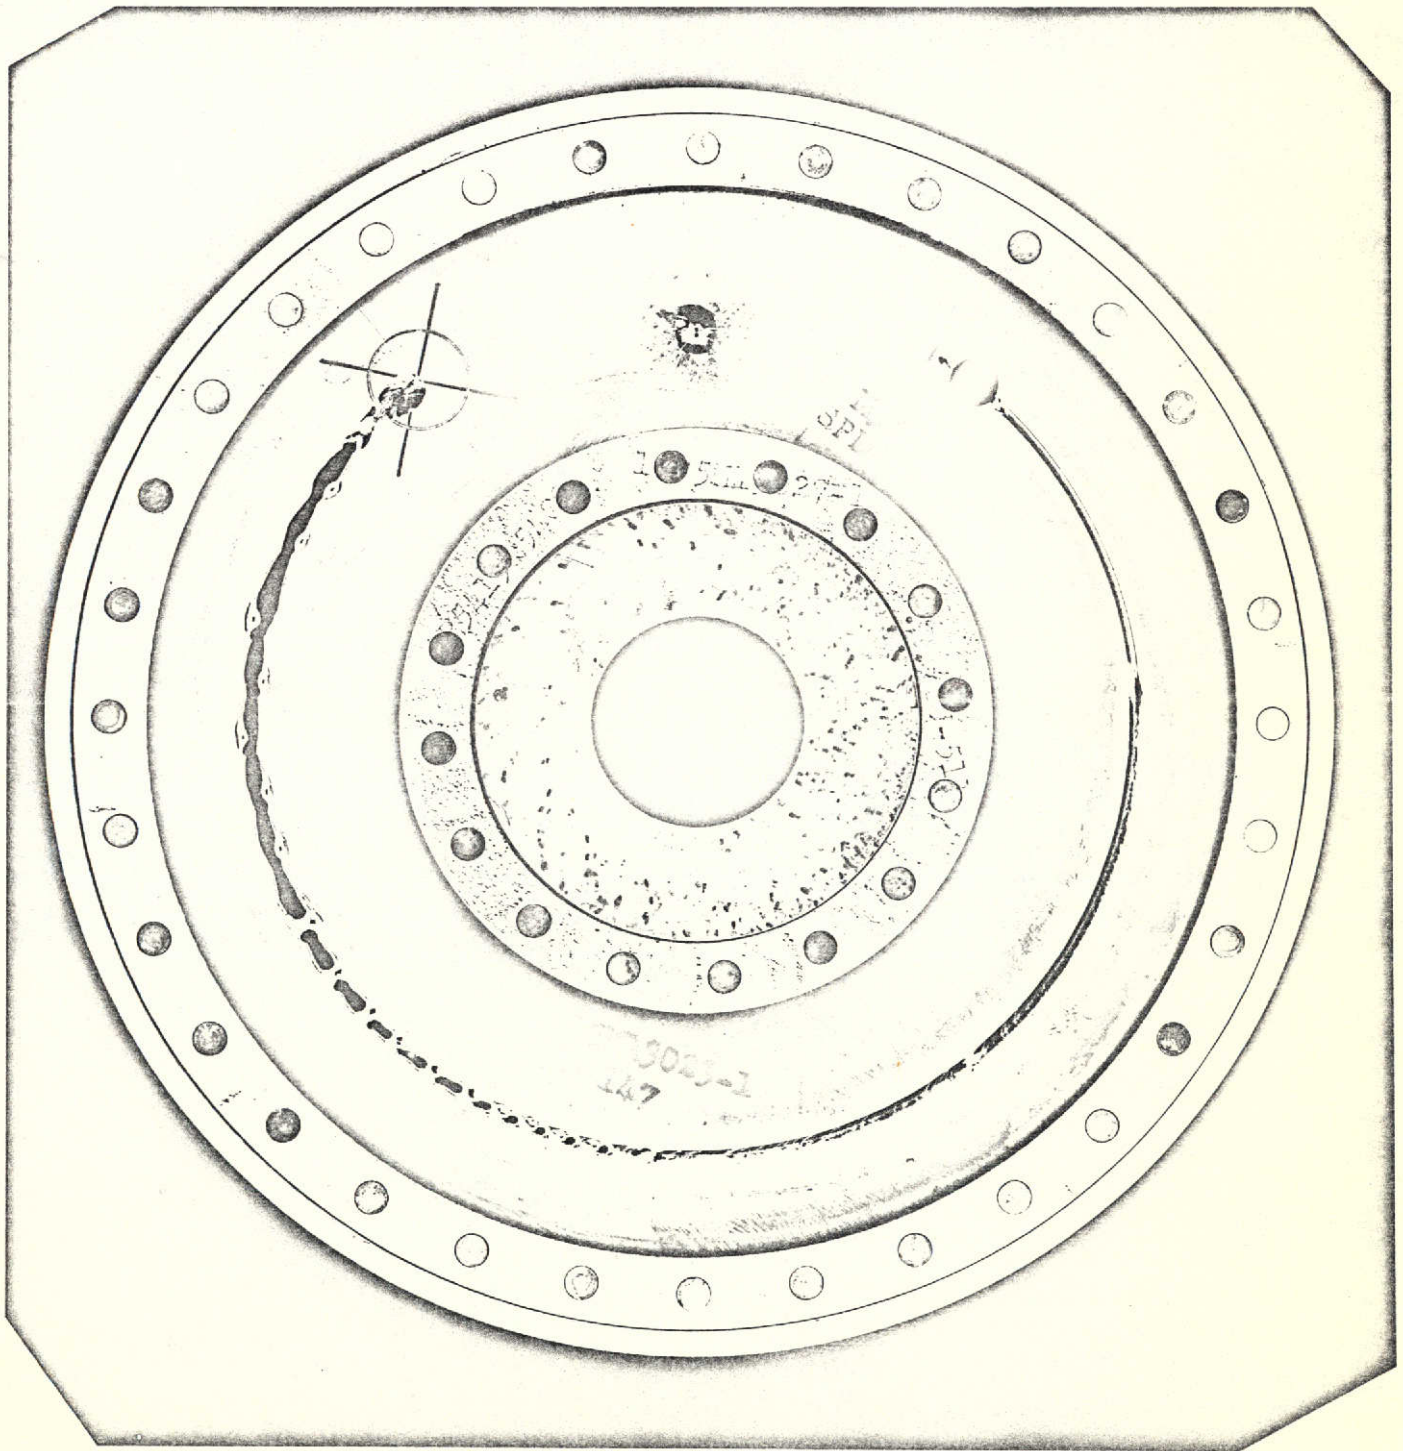
FIGURE IV-13. FRONT SURFACE S/N 147

Front Surface of Disc S/N 147

The electron beam was initiated almost exactly at the center of the target. A weld is started at this position and runs to the point where cutting begins. The cut is initially fairly wide (3mm) and there are small molten balls collected on the edges along this initial region. The cut varies in width between 1 & 3 mm. The first two balls are on the inside of the cut, the next outside, then one inside, then one out, and two more inside. Following this region of the cut, there are bridges apparent, the first bridge existing at 75 degrees. There are a total of 10 bridges before welding starts. The bridges appear to get progressively smaller in size and closer together. Compared to the bridges on SN 145, the bridges on S/N 147 do not appear to be as large or quite as spherical in shape. There is evidence of the same type of cavity on the top lower surface in the direction of increasing degrees as seen in S/N 145. The weld starts at approximately 130 degrees. The weld is uniform; about 2 mm wide, one can see both the ripples and the surface grainstructure quite readily. This weld continues on through the termination point. A surface perturbation occurs at about 180 degrees which is the point where a mass shift occurs. There is a slight depression in the weld as it enters the partial penetration region but this is quickly lost. The weld narrows slightly, at this point to 1 mm., and is quite uniform in appearance on to completion. The weld goes on to the termination hole and also slightly beyond on the opposite side. The ripple

pattern is not entirely uniform, being somewhat asymmetrical and displaced with its apex offset toward the inside of the disc<sup>(a)</sup>. The dwell region is located inside the intended target, but almost exactly on center of the inside leg of the molybdenum tracer. The dwell is almost rectangular in shape with a center cavity and an apparent pore in the center region. There is no evidence of the ripple pattern on the dwell zone. Grain boundaries coming in from the base metal can be clearly seen to extend on to the surface of the molten zone. The dwell is 5 X 6 mm.

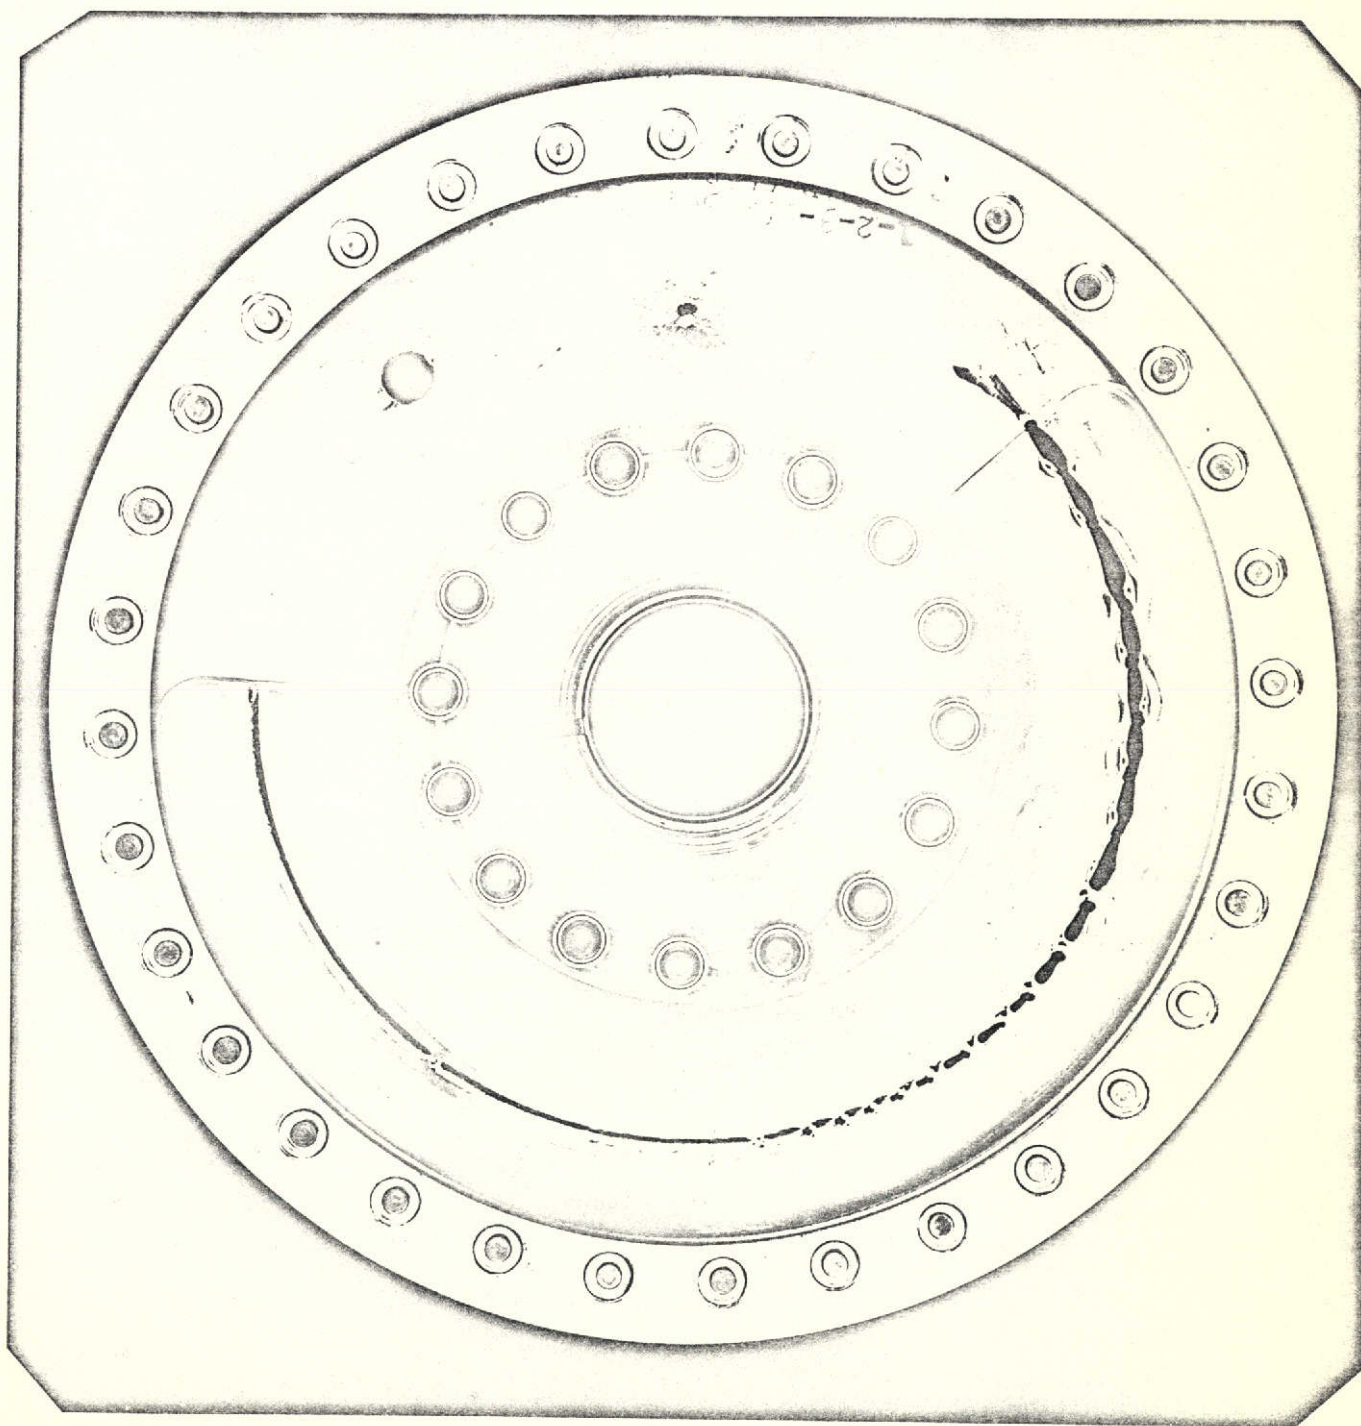
FIGURE IV-14. BACK SURFACE S/N 147

Back Side of S/N 147

Starting at the target position there is evidence of complete penetration through to the back surface of the disc. The cut begins at the transition to the thin section. The molten balls are evident on the rear of the plate and in addition, the same type of shrinkage cavity mentioned earlier on the bridges can be seen in these balls on the under surface. At the start of welding, both the ripple pattern and grain structure are quite evident. The ripple pattern on the under side is perfectly symmetrical with its apex along the weld centerline.<sup>(b)</sup> The weld appears quite uniform in appearance and in width. The same mass shift perturbation noted on the top surface is again noted on the under surface at 180 degrees. The weld continues throughout the intended full penetration region, but does not penetrate completely through the partial penetration region. There is a slight evidence of its existence in this region by virtue of a slightly discolored area.

Partial melting exists on both sides of the termination hole. In the cut region there appears to be considerable evidence along either side of the weld of some type of vaporization and subsequent deposit. The same appearance is again evident at the position where the perturbation occurs. This vaporization material would appear to possibly come from the backing plate behind the tantalum. The dwell region is completely penetrated with the under side molten zone being essentially a circular region about 3 millimeters in diameter. There is some evidence of surface roughening and grain structure apparent in the heat-affected zone. The under surface appears to be slightly depressed. There is no evidence of ripples being present in this region. Grain boundaries again extend in from base metal grain boundary regions to the molten zone.
